**DEFENDANT GENERAL MOTORS LLC'S AMENDED AND SUPPLEMENTAL
EXPERT WITNESS DISCLOSURE**

VEHICLE FINAL REPAIR OPPORTUNITY or INSPECTION REPORT

Vehicle (year/division/model): 2024 Chevrolet Camaro

VIN: 1G1FK3D63R0115556 **TAC Case #** 9-14973487177

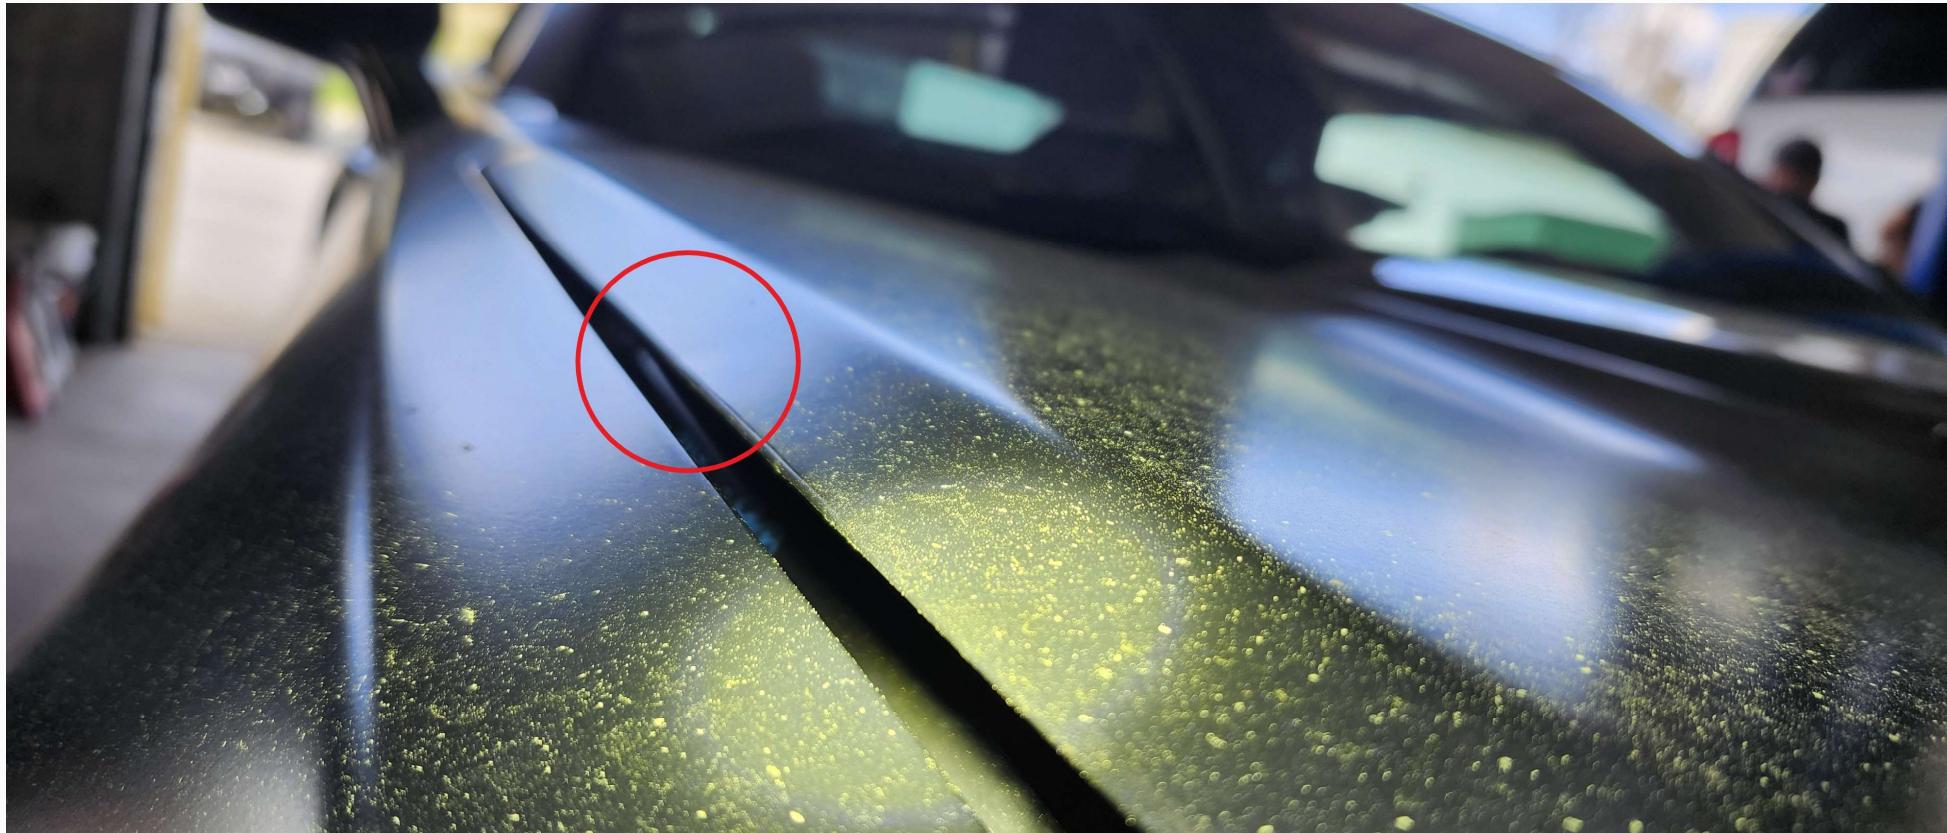
Dent in Right Side of the Hood

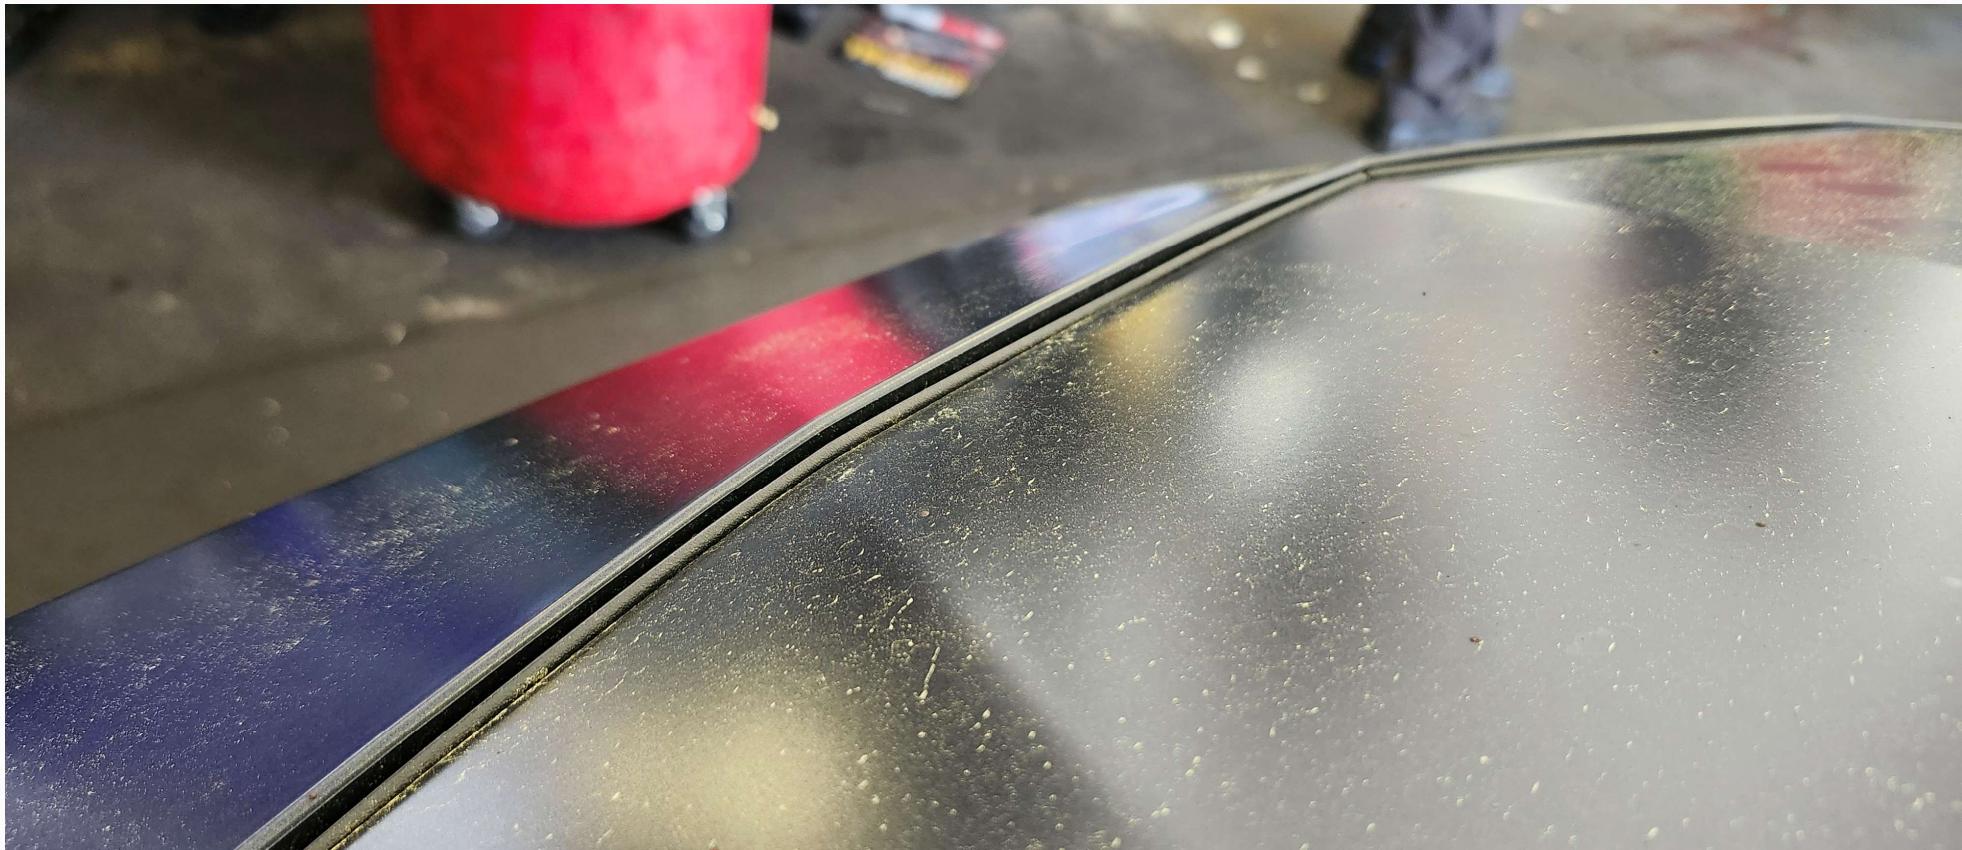
Hood to Front Facia Gap

FSE inspected vehicle but did not make any repairs or removed any panels during the inspection. FSE measured hood gap between the hood and front bumper fascia. The perimeter gap around the hood was uneven and front leading edge of the hood was lower than the front bumper fascia. FSE believes the gap could be corrected with hood, hood striker, and bumper fascia adjustment. The front leading edge of the hood should sit below the bumper fascia to prevent wind noise and excessive air getting trapped under the hood, causing the hood to rattle. Customer had a complaint of the rear bumper fascia attachment points on the left and right quarter panels. FSE inspected the attachment points and found very minimal protrusions and no adjustments will correct the customers' complaint. FSE compared other similar
